Grain Dust Explosions: A Report from South America

Roberto D. Hajnal

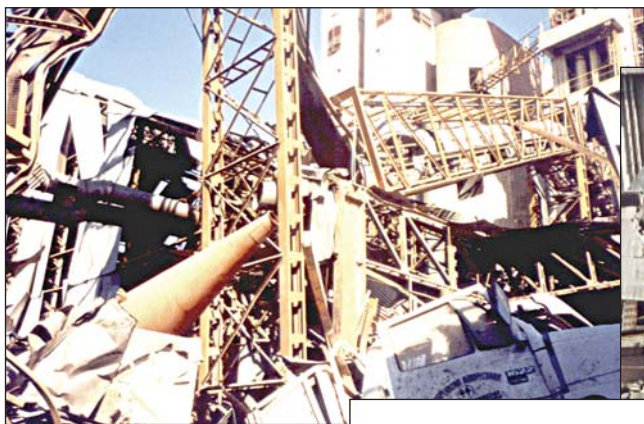
Two scenes (above and far right) from the ACA San Lorenzo Terminal explosion in Argentina in 2002. This explosion killed three people and injured nineteen.

The ACA San Lorenzo explosion, Argentina, April 2002

An unknown ignition source ignited dust within the facility and resulted in a series of explosions that severely destroyed the heart of the port facility. The actual ignition source may never be known due to the damage that occurred in the tunnel beneath the horizontal silo, where the first or primary explosion started, and because the employee working in this area at the time of the explosion was killed.

This underground infrastructure was a long network of confined spaces that distributed and accelerated the propagation and intensity of the explosion.

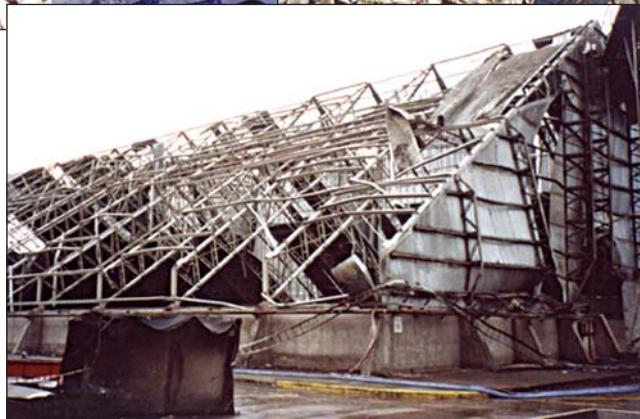
The Toepfer Puerto San Martín explosion in Santa Fe, Argentina in 2001 started with a primary explosion that caused chain-reaction second and third explosions.

The Toepfer Puerto San Mart n Explosion, Argentina, October 2001

The first or primary explosion started underneath the steel bins, in the tunnel. Standing dust on the floors and edges was stirred up by the shock wave caused by this primary explosion, and provided the fuel for a secondary explosion, which was much more violent than the first, expanding quickly through the connecting tunnel to the tunnel underneath the horizontal silo, where the workers were. The horizontal silo was empty but two workers inside the tunnel were killed instantly and a third, working on the floor of the flat silo, was killed as the concrete tunnel roof blew up. A chain reaction of ever-increasing intensity had been set in motion that cul-

minated with a third explosion that impacted the reception area (about 300 meters away from the starting point), and other concrete and metallic structures.

Experts think that the Toepfer explosion was due to hexane gas rather than grain dust. Since rebuilding hexane monitors have been installed in the tunnels which detected gas leaking into the tunnels under the storage from the crushing plant next door. Steps were taken on both sides to correct this dangerous situation.

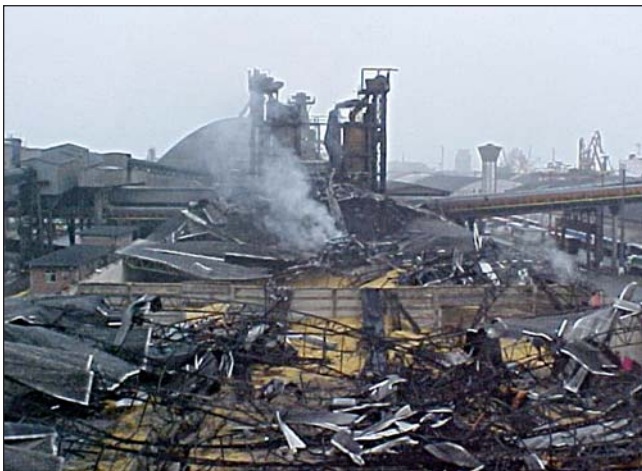
The 2001 Coinbra Paranagu  Terminal explosion in Paran , Brazil, blew five-ton pieces of concrete 300 meters, and grain continued to burn for nearly three weeks.

The Coinbra Paranagu  Explosion, Brazil, November 2001

The explosion started in the shipping bucket elevators that were in operation, and was most probably due to belt misalignment. This primary explosion expanded quickly throughout the whole facility. The first explosion caused dust within the facility to be placed into suspension in the air, thereby contributing to a series of subsequent explosions. The secondary explosion was so strong that all resistant structures collapsed, even rail cars were turned like toys, big pieces of concrete that weighed over five tons were blown 300 meters away, and the steel shipping tower was turned down to earth. The destruction was followed by fire, which ignited the grain and continued burning for nearly three weeks.
